Subject: Trip Report and Data Summary
Removal Assessment Support, Dugan & Helterbrand Site, Marshfield, Missouri
CERCLIS ID: MOD86919248 (Archived)
U.S. EPA Region 7 START 3, Contract No. EP-S7-06-01, Task Order No. 0241
Task Monitor: Paul Doherty, EPA On-Scene Coordinator

TRIP REPORT AND DATA SUMMARY
FOR REMOVAL ASSESSMENT SUPPORT
DUGAN & HELTERBRAND SITE
MARSHFIELD, MISSOURI
CERCLIS ID: MOD86919248 (Archived)

Superfund Technical Assessment and Response Team (START) 3
Contract No. EP-S7-06-01, Task Order 0241

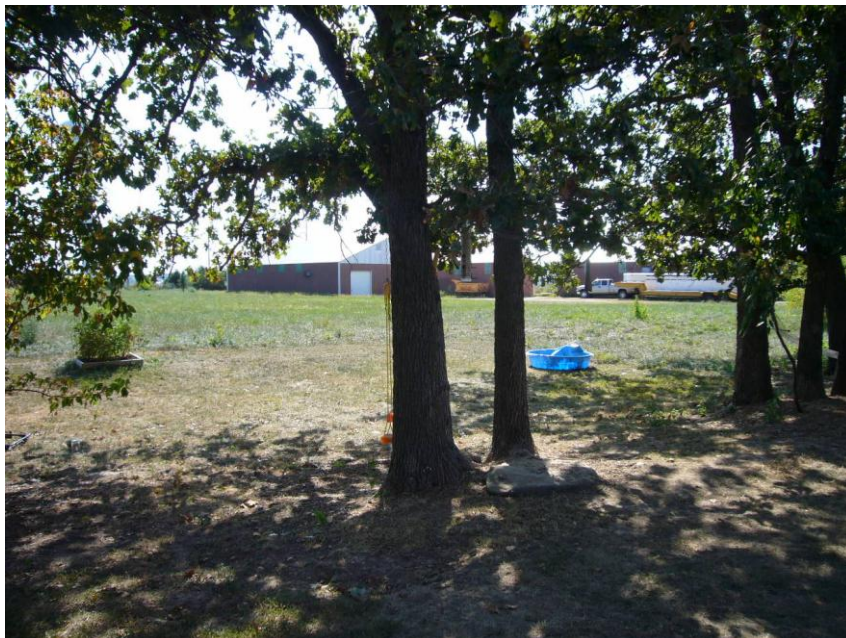
<p>TETRA TECH PROJECT NO. X9004.11.0241.000 DIRECTION: Southeast</p>	DESCRIPTION	This photograph shows view of former D&H facility from backyard of residence at 470 George Street.	2
	CLIENT	Environmental Protection Agency - Region 7	DATE 9/13/11
	PHOTOGRAPHER	Jenna Mead

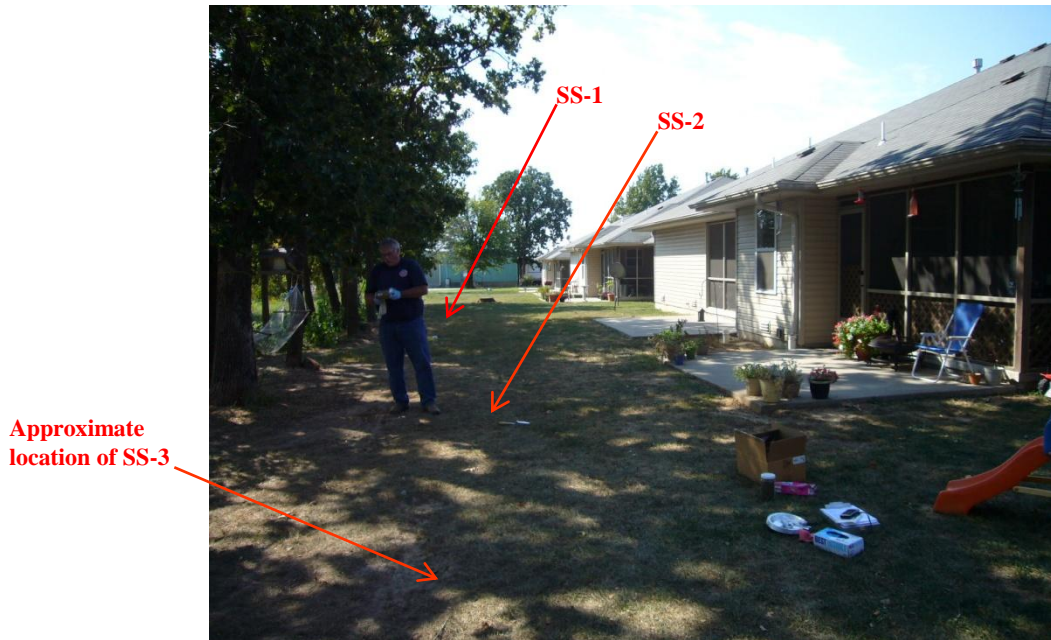
TETRA TECH PROJECT NO. X9004.11.0241.000 DIRECTION: South	DESCRIPTION	This photograph shows backyard play area at 470 George Street duplex and locations for surface soil (SS) samples.	3
	CLIENT	Environmental Protection Agency - Region 7	DATE 9/13/11
	PHOTOGRAPHER	Jenna Mead

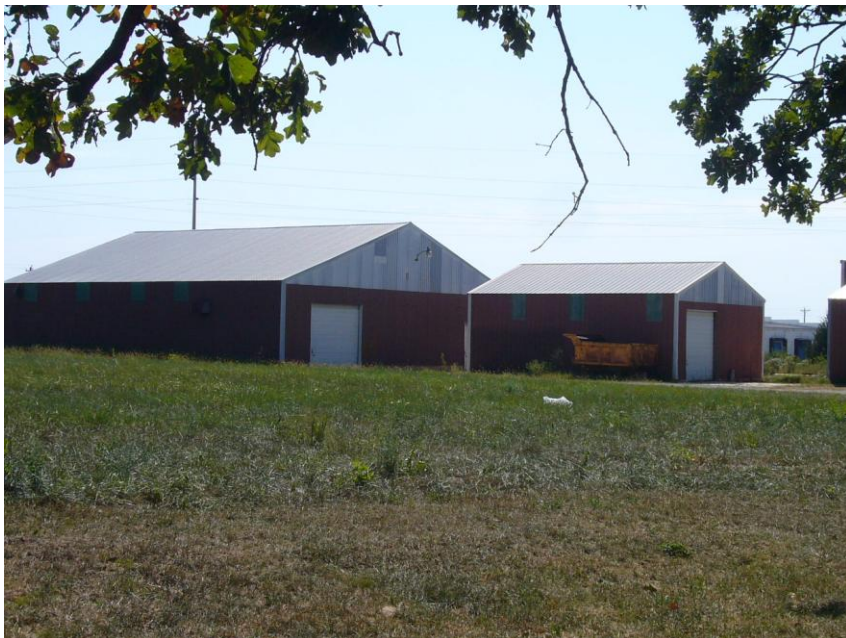
TETRA TECH PROJECT NO. X9004.11.0241.000 DIRECTION: Southeast	DESCRIPTION	This photograph shows view of former eastern production building and central tool shop at D&H site.	4
	CLIENT	Environmental Protection Agency - Region 7	DATE 9/13/11
	PHOTOGRAPHER	Jenna Mead

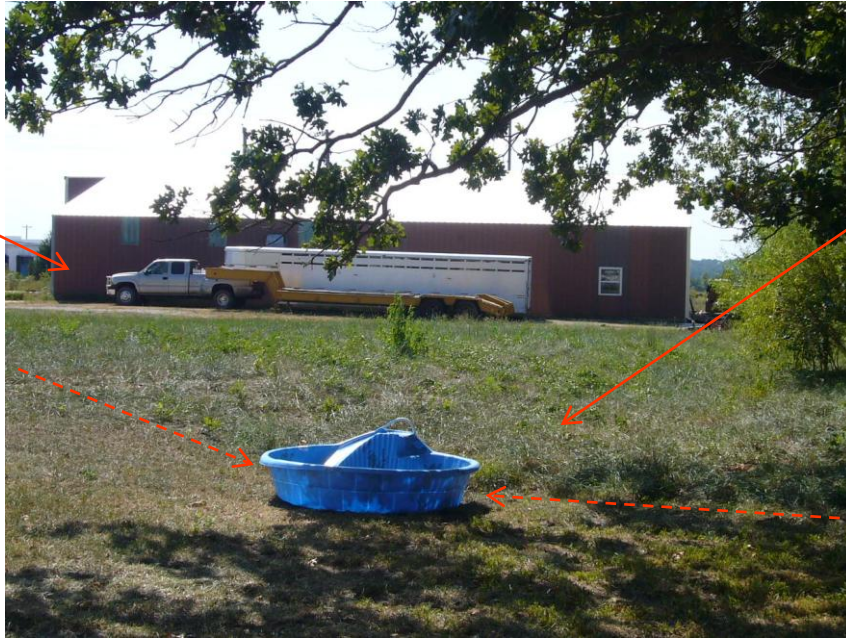
**Approximate
location of
SS-8**

**Unmowed
drainage
swale**

**Mowed
swale**

TETRA TECH PROJECT NO. X9004.11.0241.000 DIRECTION: Southeast	DESCRIPTION	This photograph shows former D&H western production building. Note the drainage swale has been mowed to increase the play area.	5
	CLIENT	Environmental Protection Agency - Region 7	DATE 9/13/11
	PHOTOGRAPHER	Jenna Mead

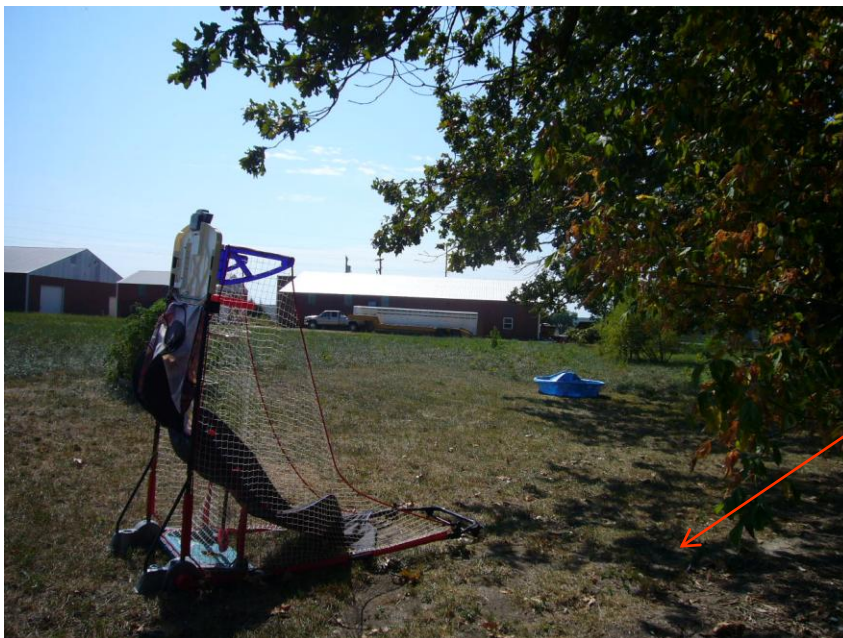
**Approximate
location of
SS-5**

TETRA TECH PROJECT NO. X9004.11.0241.000 DIRECTION: Southeast	DESCRIPTION	This photograph shows play area in drainage swale east of residence at 470 George Street. Former D&H facility shown in distance.	6
	CLIENT	Environmental Protection Agency - Region 7	DATE 9/13/11
	PHOTOGRAPHER	Jenna Mead

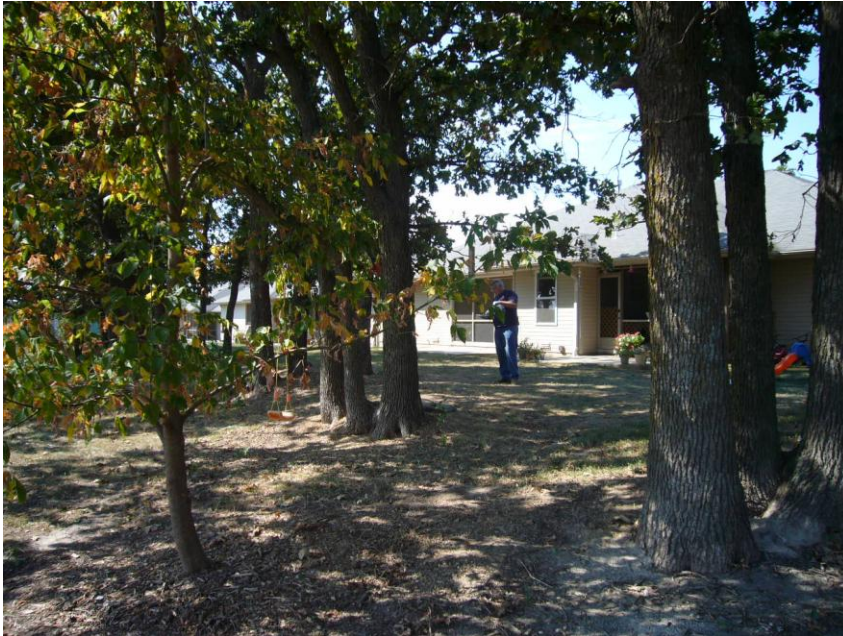
<p>TETRA TECH PROJECT NO. X9004.11.0241.000 DIRECTION: Southwest</p>	DESCRIPTION	This photograph shows view from drainage swale of trees along the eastern property line and backyard of residence at 470 George Street.	7
	CLIENT	Environmental Protection Agency - Region 7	DATE 9/13/11
	PHOTOGRAPHER	Jenna Mead
